TROPICANA

Re: Submission of Tropicana Gold Mine (Ministerial Statement No. 839) 2014-2015 Annual Compliance Assessment Report

Tropicana Gold Mine (TGM) Ministerial Statement No 839 Annual Compliance Assessment Report 1 September 2014 to 30 September 2015

Document Reference: CAR20151224

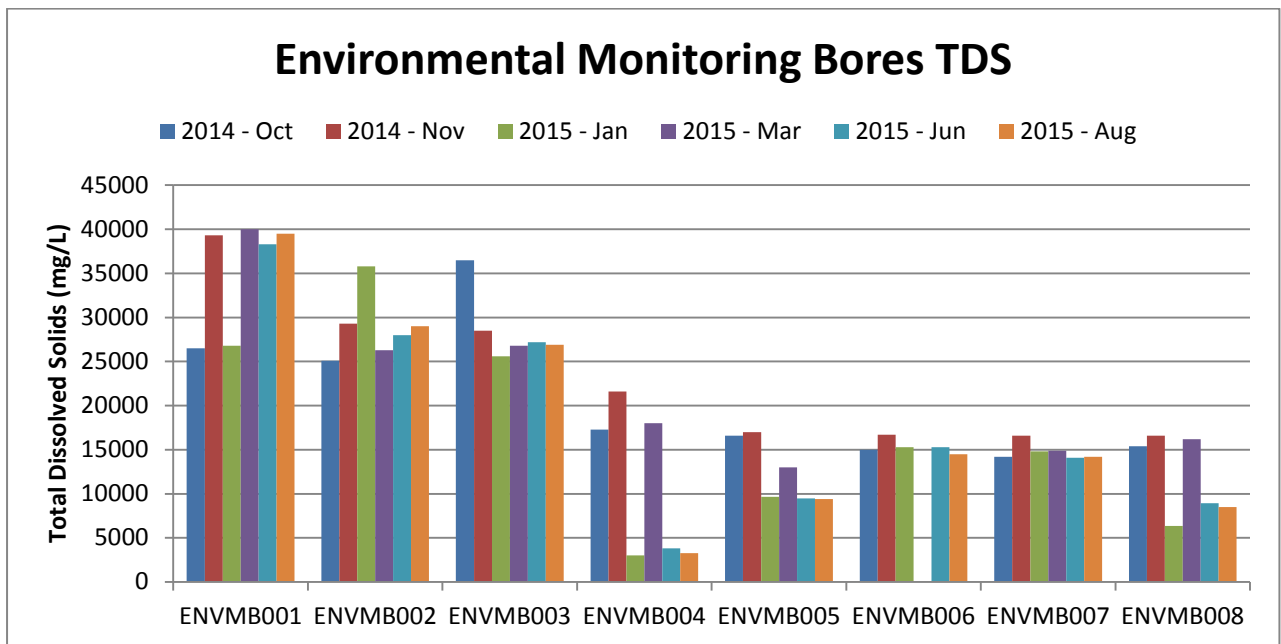
Figure 4: Total Dissolved Solids recorded in the Environmental Monitoring Bores (Oct 2014 to Sep 2015)

Total dissolved solids recorded at the Environmental Monitoring Bores during the reporting period ranged between 3,030 mg/L (recorded at ENVMB004) and 40,000 mg/L (recorded at ENVMB001) (**Figure 4**). These results do not exceed the baseline range (3,270 to 41,100 mg/L), however a lower minimum was recorded at ENVMB004.

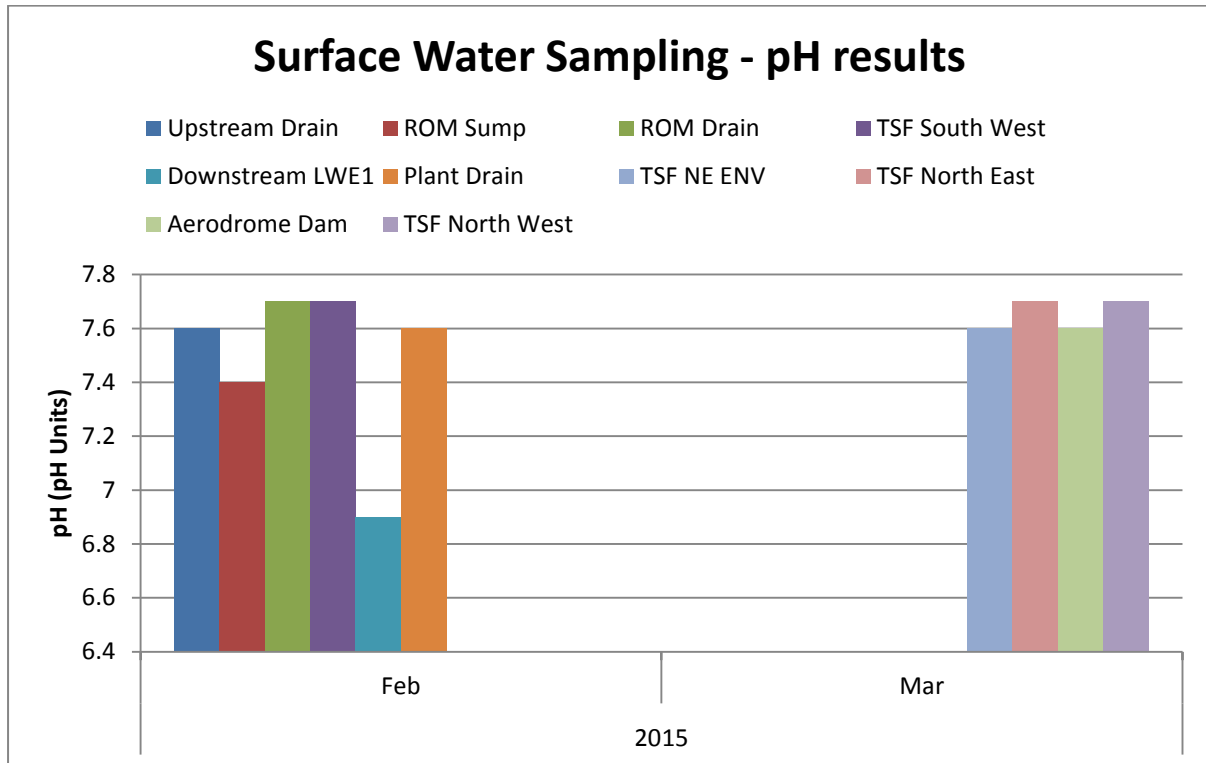
Figure 2: pH Recorded during Surface Water Monitoring (Oct 2014 to Sep 2015)

The pH of samples collected across the surface water sampling locations ranged between 6.9 and 8 pH units with levels typically ranging between 7 and 8 pH units (**Figure 2**).

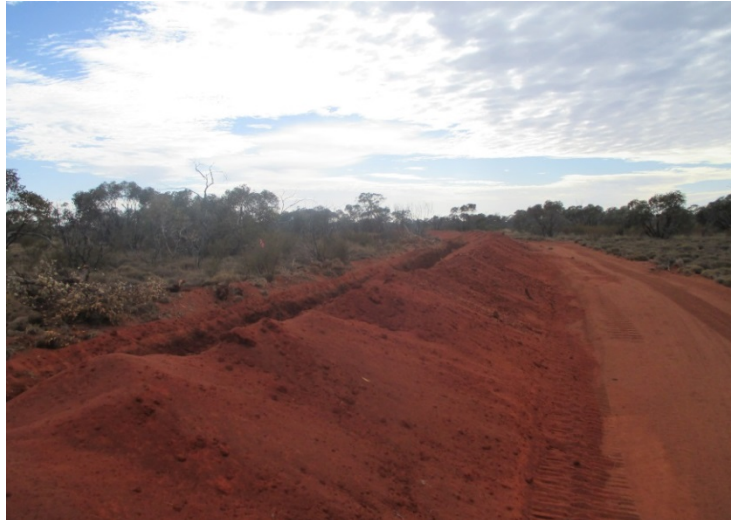
Plate 1: Overview of Open Trench PWSB

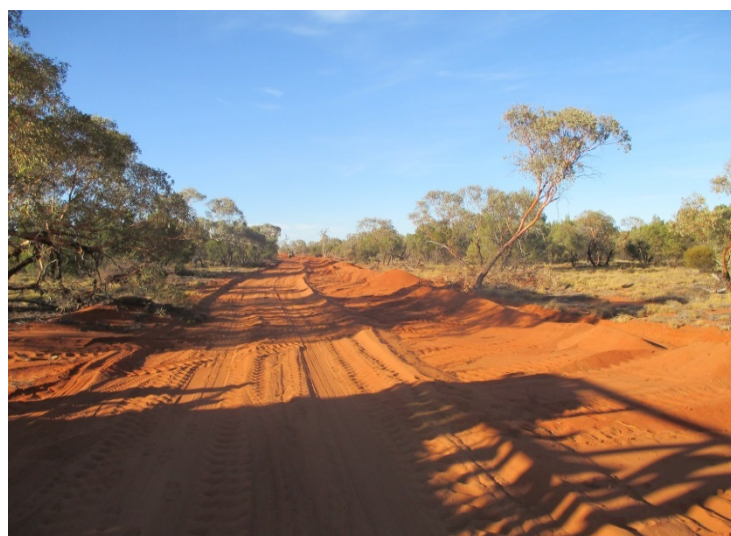
Plate 3: Backfilled Trench
